Goodes Bridge Center

Physical Assessment

Amelia County, VA

November 2, 2015

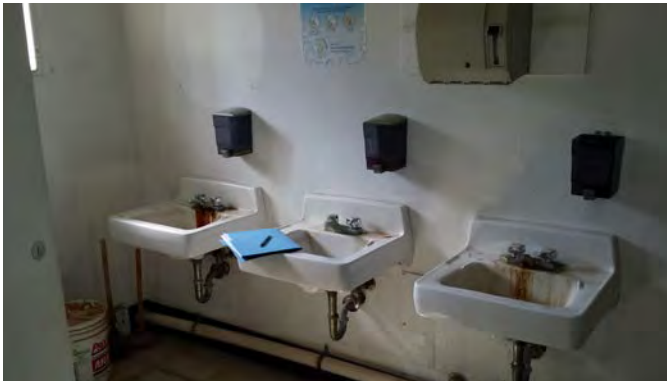
Typical Condition of Restrooms 1967 Metal Building (Borum Shop)

- Several interior metal wall liners in the 1967 metal building were dented.
- Both restrooms in the 1967 metal building are in very poor condition. All toilet fixtures (toilets, urinals, and lavatories) are stained and most are not operational. Both restrooms need a complete renovation and made ADA accessible.
- In the 1950 metal building water is entering the building at the roof panel laps causing the vinyl backed insulation to sag. Once leaks are stopped the insulation should dry out.

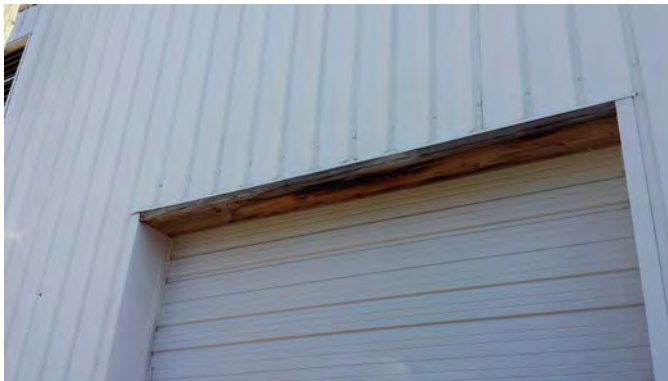
Aluminum Trim Missing at 1967 Metal Building (Borum Shop)

- Exterior metal wall panels are in good condition. Only a few were noted as dented or rusted. Replace or repair all rusted and dented wall panels.
- Exterior hollow metal doors and frames are rusted and dented and none of the exterior doors have panic hardware. Replace all exterior hollow metal doors and provide panic hardware.
- Manual overhead sectional doors in the 1950 Metal Building appear operational.
- One electrically operated overhead sectional door in the 1967 Metal Building is out of level with a large gap at bottom on one side of the door. The other sectional door is missing the aluminum trim at the head of the door. Align sectional door and install aluminum trim at head of door.

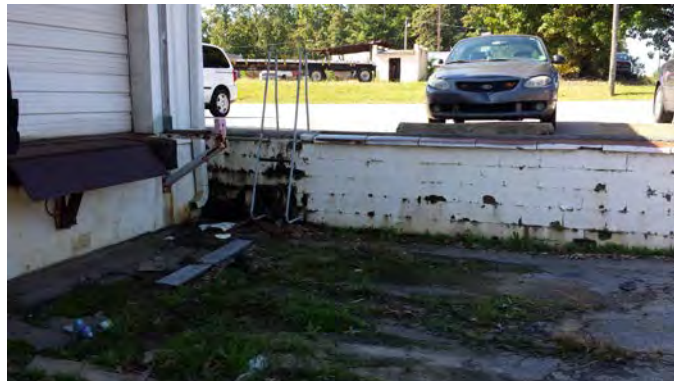
Retaining Wall at Loading Dock

- Need to remove all loose and flaking paint, water proof, prime and paint all concrete blocks the entire length of the retaining wall.

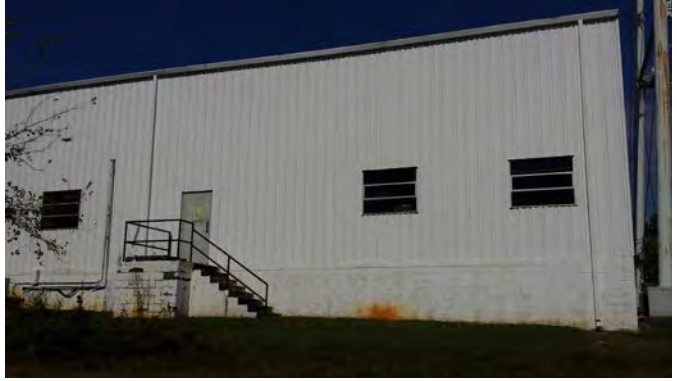
Existing Painted Block Foundation and Steps/Landing at 1967 Metal Building

- Exposed block at base of 1967 Borum Metal Building needs to be painted (occurs at rear and one side of building).
- One set exterior concrete steps and landing are deteriorated beyond repair and should be replaced.

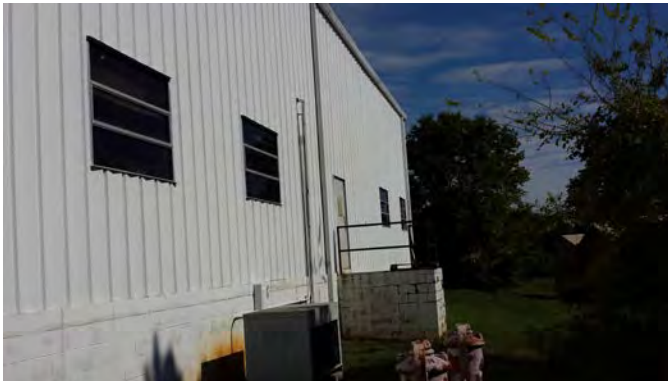
Existing Painted Block Foundation and Steps/Landing at 1967 Metal Building

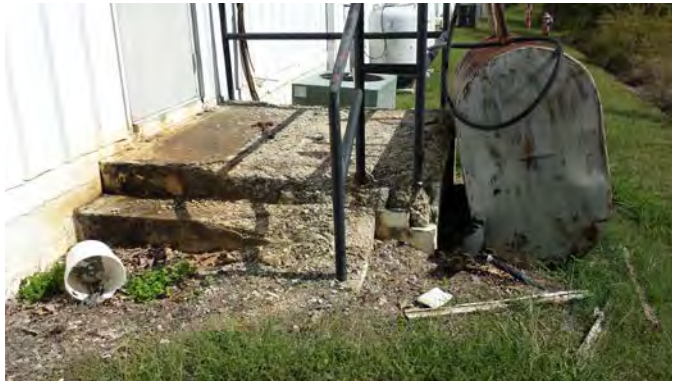
Existing Concrete Steps and Landing 1967 Metal Building

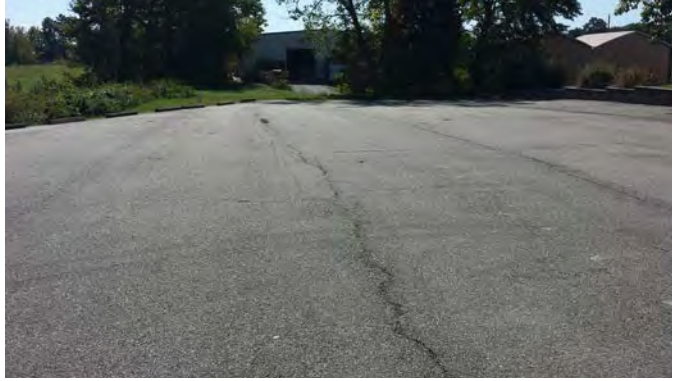
Front Parking Lot - Minor Cracking in Paving

- Paving at parking lot and service drive appears to be in good condition except minor cracking was observed throughout. We recommend you fill all cracks and seal all pavement.
- All paint lines at parking spaces have faded and need to be repainted.

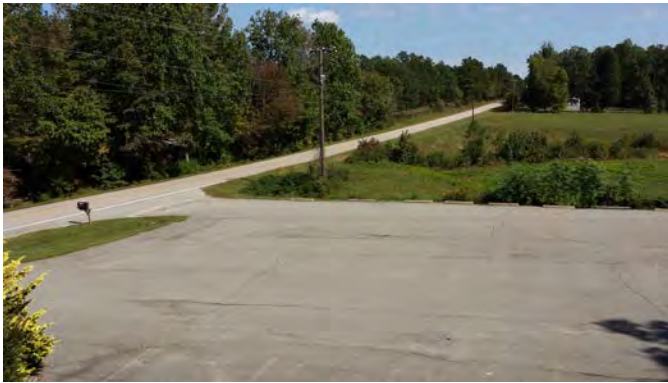
Front Parking Lot - Minor Cracking in Paving

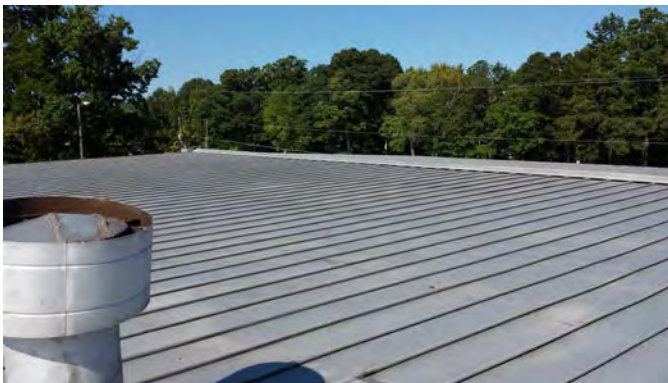
Typical Condition of Standing Seam Roof Over 1950 Metal Building

- The existing roof is a standing seam metal roof. Only minor repairs are needed.
- The standing seam metal roof has one row of alternating roof panel laps along the entire length of the building. It appears water is entering the building at the roof panel laps causing the vinyl back insulation on the interior of the building to sag. Water was observed on the concrete slab in one location. Seal all roof panel laps.
- Repairs have been made at all roof penetrations and minor rusting has occurred at roof panels adjacent to roof curbs.
- Gutters are ponding very little water.

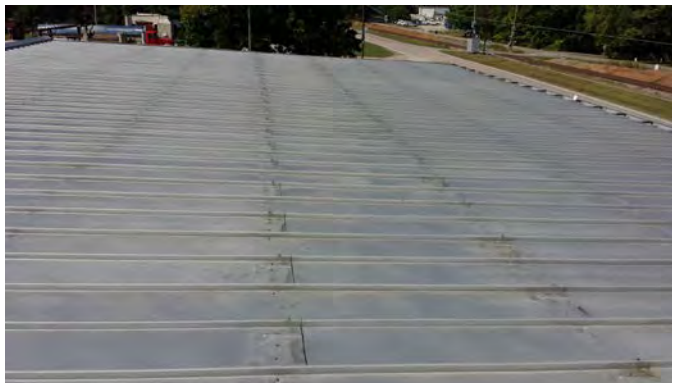
Standing Seam Roof Panels Showing Extent of Panel Laps (1950 Metal Building)

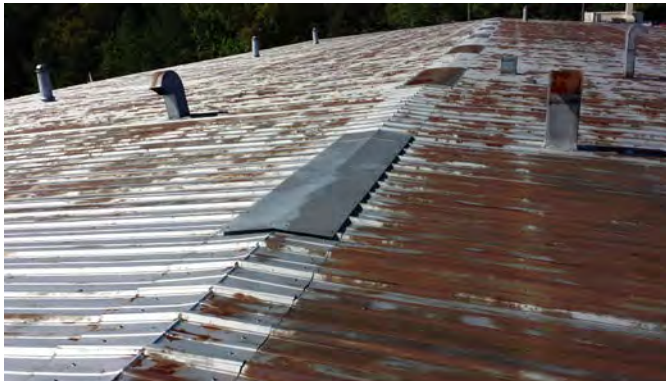
Ridge Repairs on the 1967 Metal Building (Borum Shop)

• Ridge Panel		✓			repairs have been made - sheet metal installed along ridge in several areas	
• Gutters		✓			minor ponding of water/approximately 20 LF of gutters are rusted

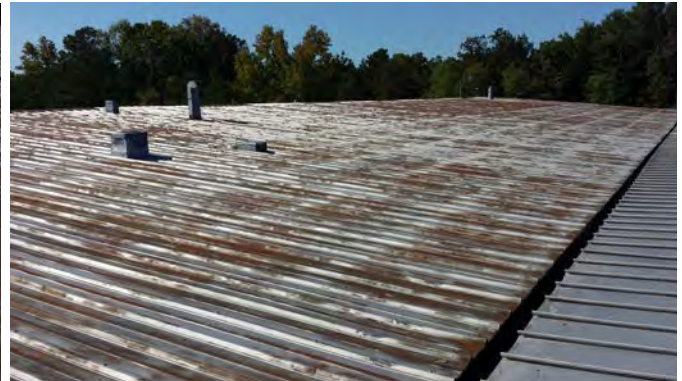
Typical Condition of Screw Down Metal Roof Over 1967 Metal Building (Borum Shop)

One major expense identified in the report has to do with the recommendations to replace or overlay the 1967 metal roof system. The existing metal roof panels have a lot of surface rust over the majority of the roof panels. Given its age and the presence of surface rust we recommend the roof system be replaced or overlaid with a new metal roof. Replacement would include the removal and replacement of one roof panel at a time so contents of the interior are not exposed to inclement weather. An option called the Hugger System leaves the existing roof intact and a new metal roof system is installed on top of the existing (roofhugger.com). Spray-on paint coatings are seen as quick fixes and would cover the rust but normally fail to permanently fix existing roof systems.

- The existing roof is a screw down metal roof and no leaks were observed at the time of this inspection. The metal roof has one row of panel laps along the entire length of the building. The majority of the metal roof has surface rust. Due to the age of the roof and the extent of rusting we recommend replacing the existing metal roof. An option may be to overlay the existing metal roof with a Roof Hugger System (metal roof overlay).
- The majority of the metal roof panels have surface rust and most screw heads have been caulked.
- Roof repairs have been made at all roof penetrations.
- Sheet metal repairs have been made to the roof ridge in numerous locations.
- Gutters are ponding very little water.
- The interior gutter located between the 1950 and 1967 building is leaking in one location. Wet block was observed at the firewall in the Borum Shop area (see photos).

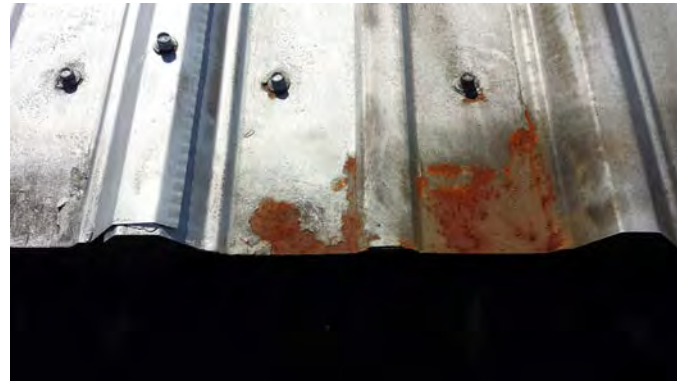
Typical Condition of Screw Down Metal Roof at 1967 Metal Building (Borum Shop)

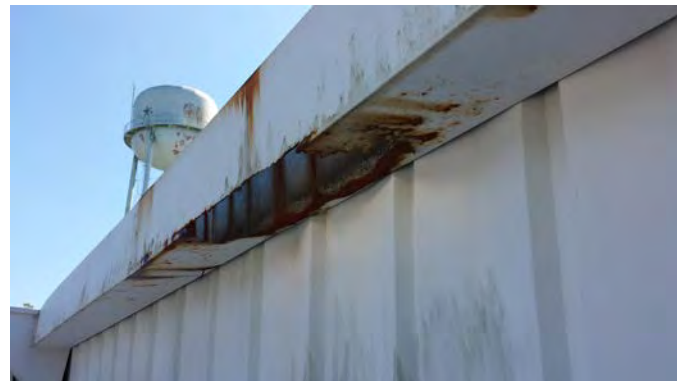
Rusted Gutter on Higher Roof (2 locations) Adjacent to Loading Dock Roof

• Roof Penetrations		✓			roof panels adjacent to both hot stacks (flues) are rusting and repairs are needed	
• Ridge Panel	✓					
• Gutters		✓			minor ponding of water/approximately 20 LF of gutters are rusted at dock area

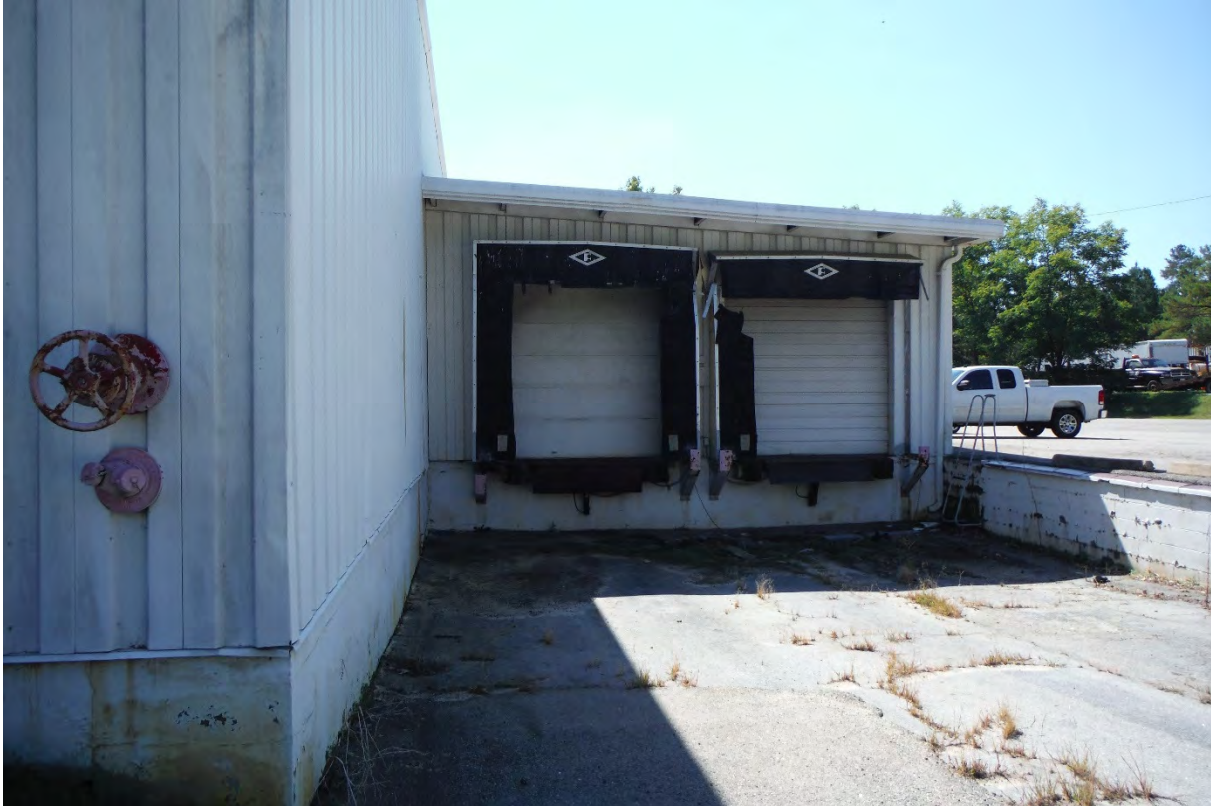
11. Loading docks and stormwater drain (below docks) observed on northern side of building.

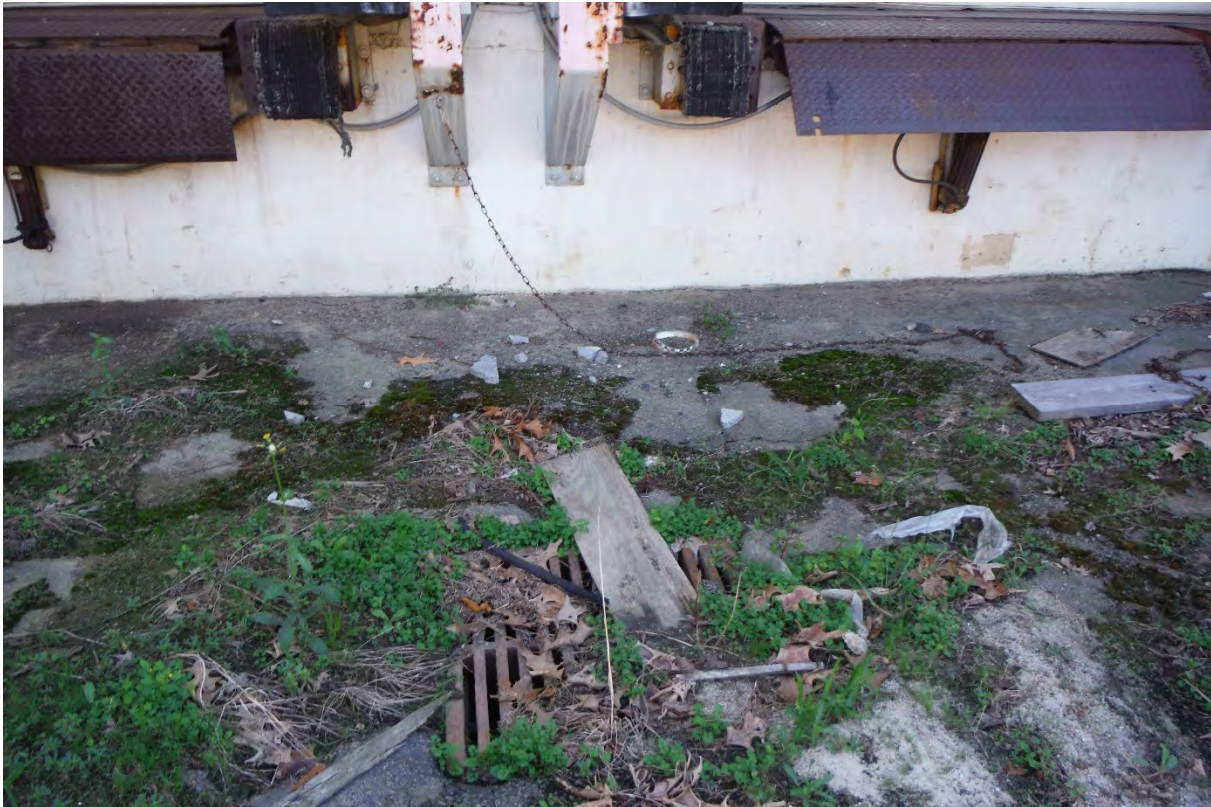
12. Stormwater drain below loading docks.

- Paving at loading dock around the storm drain inlet appears to be deteriorated and should be replaced.
- While water was not ponding around the storm drain inlet at the time of inspection, the presence of vegetation indicates this area is holding water. Verify storm drain line is operational.

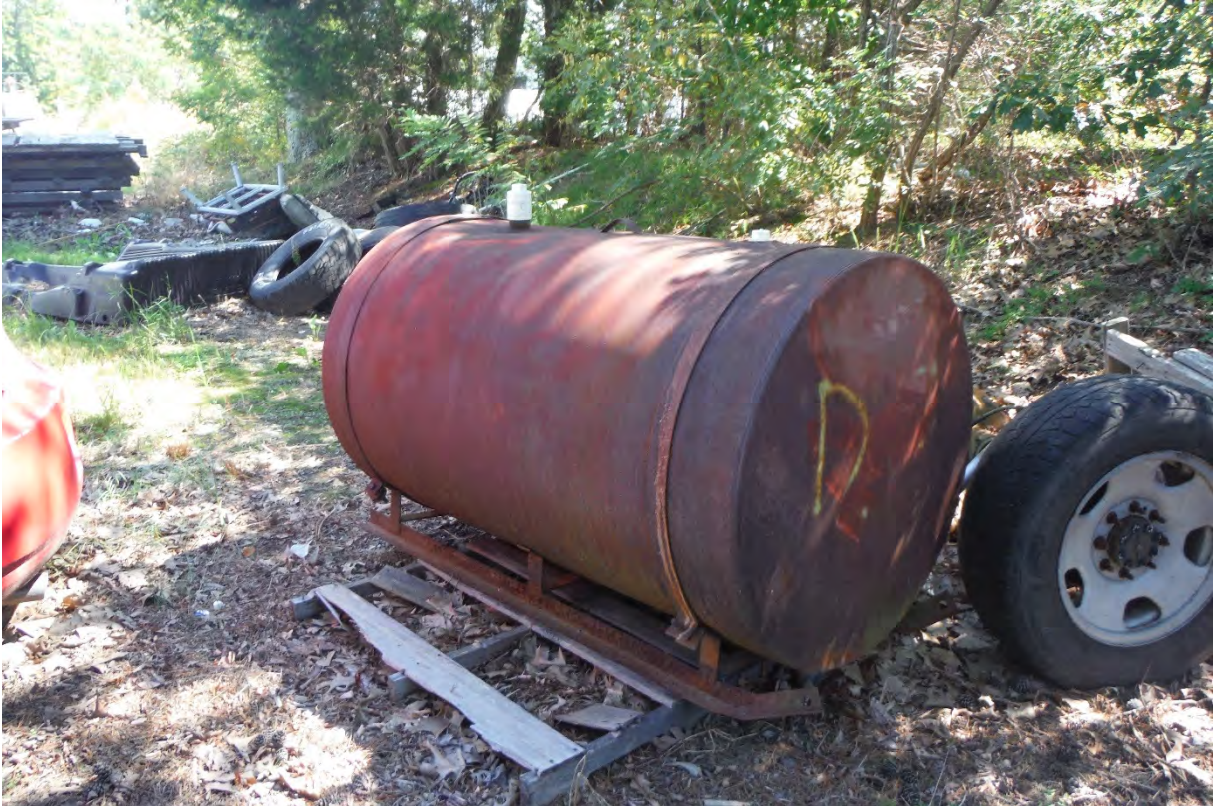
19. AST located behind dumpster on west side of building. AST appeared to be empty. Staining below the AST was not observed.

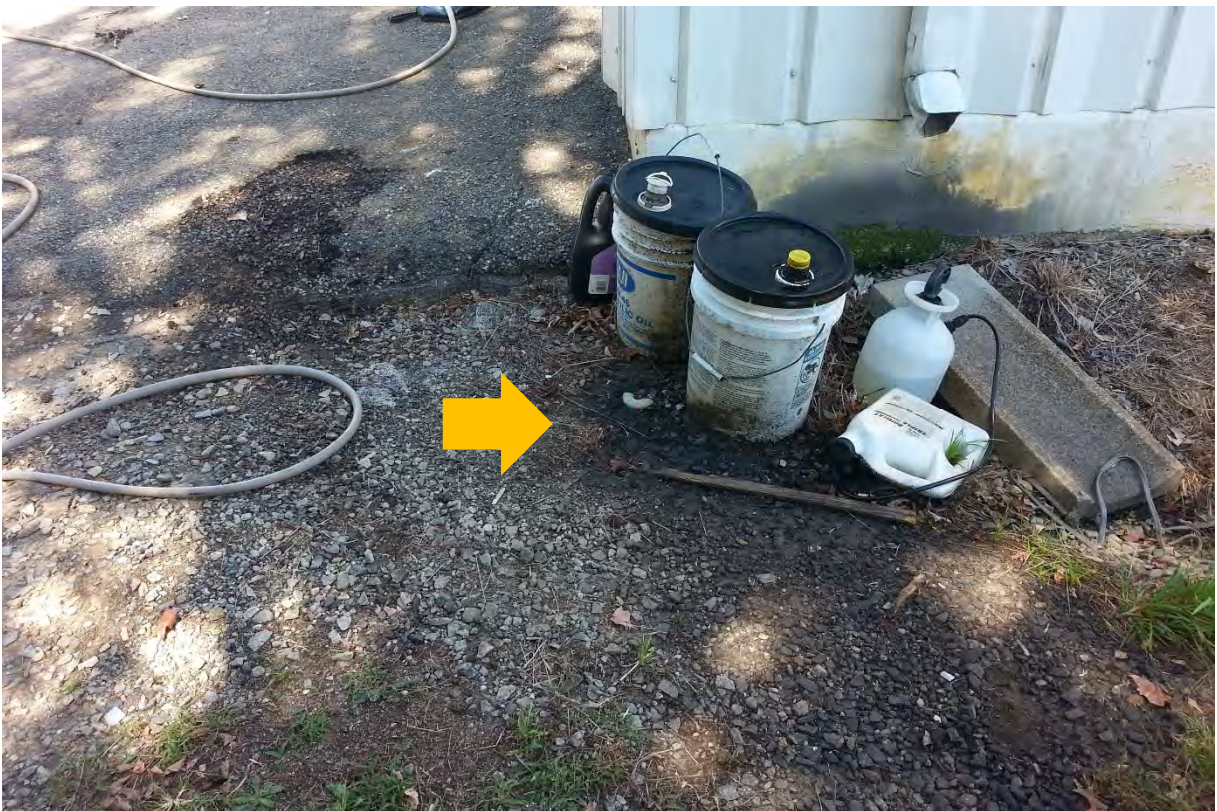
20. Photo taken at southwestern corner of building. Staining observed around 5 gallon buckets.

samples should be collected within the subject property in similar locations to those collected in F&R's 2004 limited Phase II report. Additional soil sampling is recommended within the vicinity of the petroleum staining observed at the southwestern corner of the building.

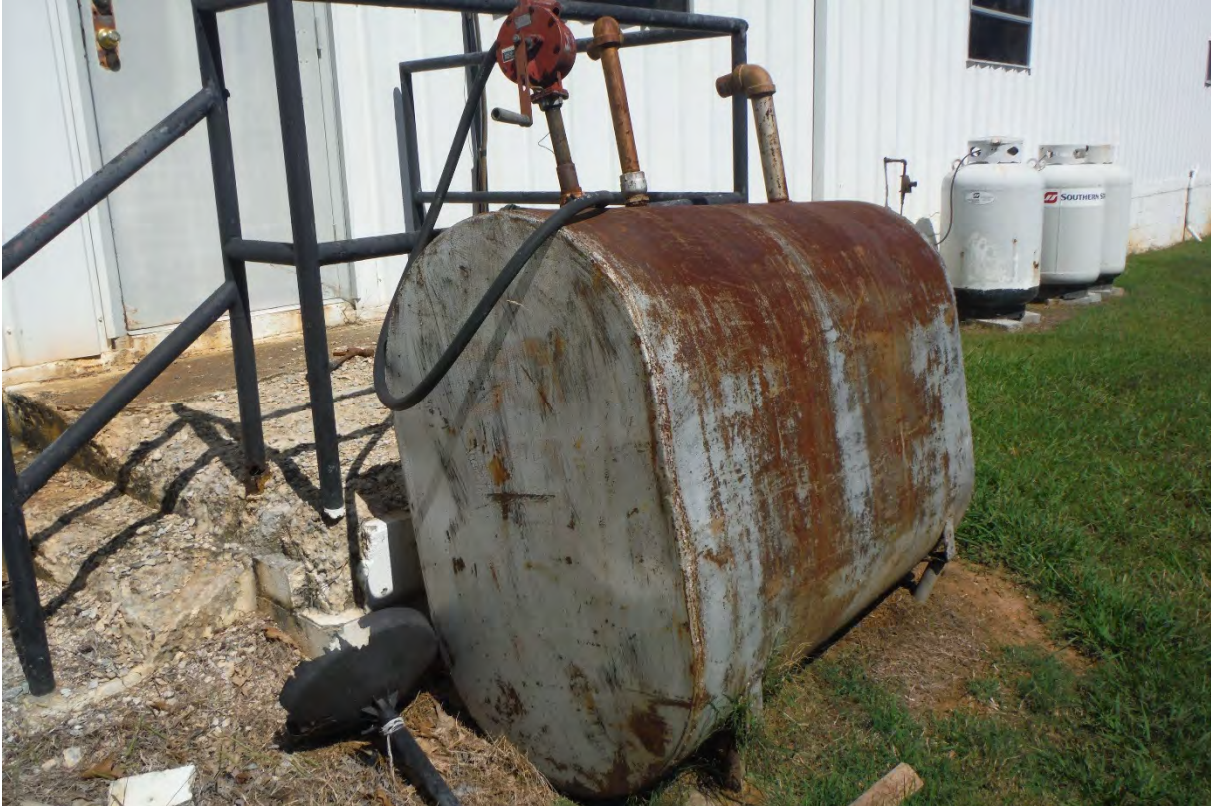
21. AST on southern side of building. AST appeared to be partially empty.

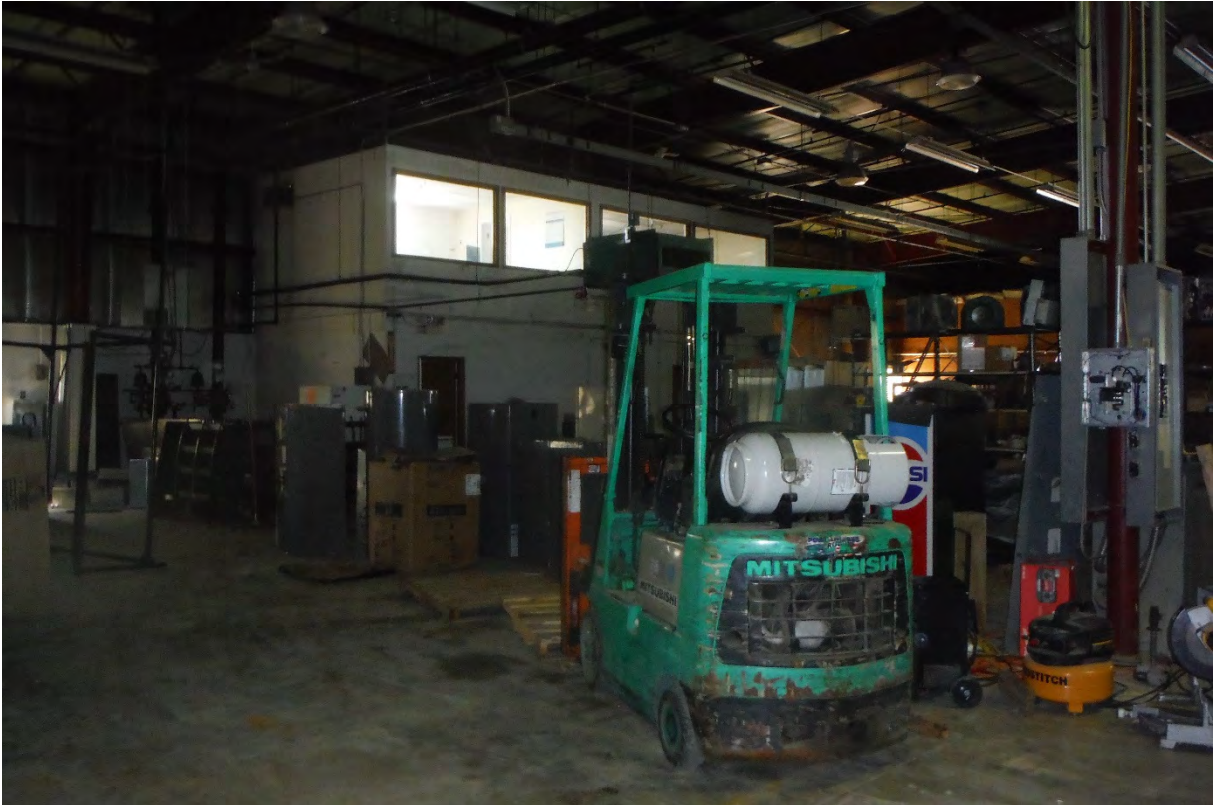
36. Photo taken of the southern wall of the southern warehouse. Second floor offices seen in center of frame. Minor superficial staining observed around the forklift.

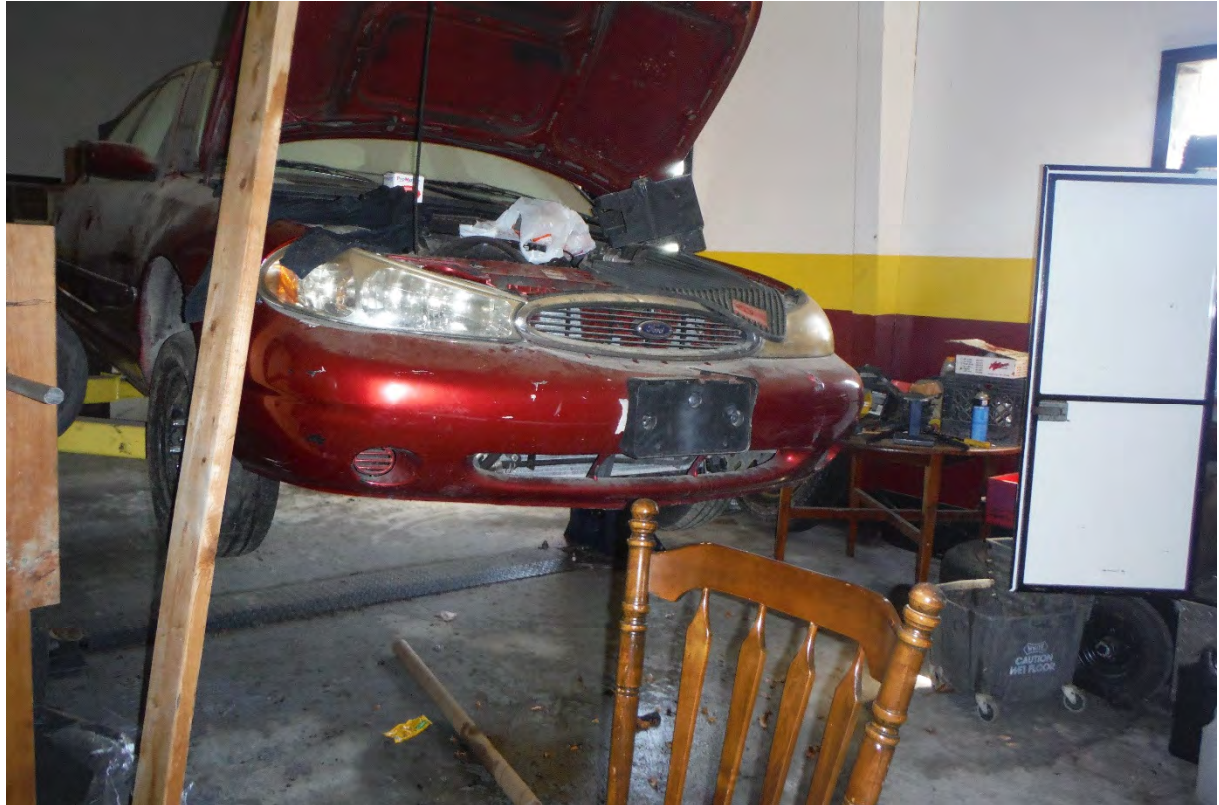
42. Car on car lift. Superficial staining observed below car.
